**Tribological Properties of Alumina-  
Boria-Silicate Fabric from  
25 to 850 °C**

Christopher DellaCorte  
National Aeronautics and Space Administration  
Lewis Research Center  
Cleveland, Ohio 44135

March 1988

1. Report No. <b>NASA TM-100806</b>	2. Government Accession No.	3. Recipient's Catalog No.	
4. Title and Subtitle <b>Tribological Properties of Alumina-Boria-Silicate Fabric from 25 to 850 °C</b>		5. Report Date <b>March 1988</b>

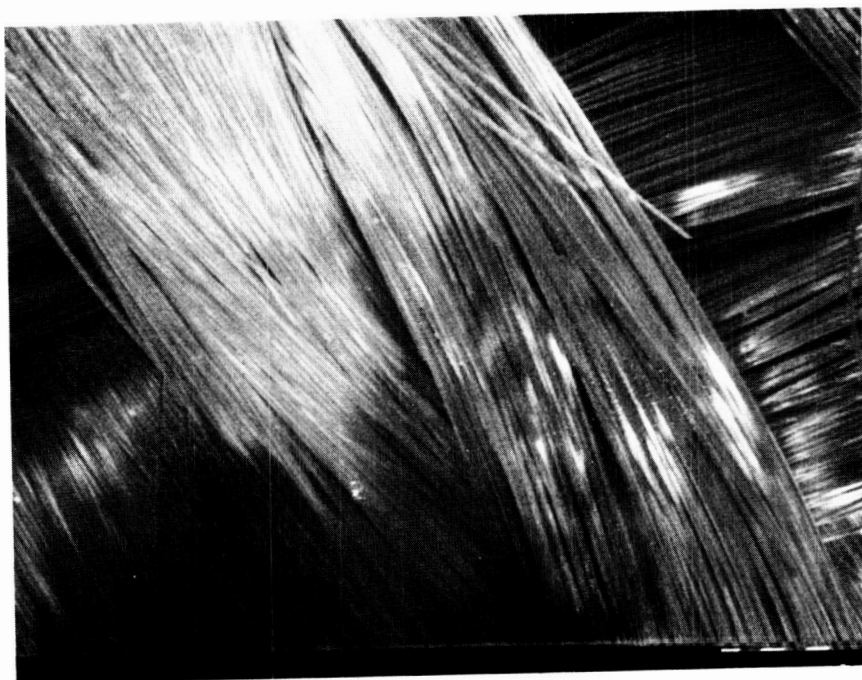
FIGURE 2. - VIRGIN FABRIC BUNDLE 50x.

A fabric woven from Alumina-Boria-Silicate fiber was tested in this program. The composition of the fibers, designated AF-40, by weight is, 62 percent  $Al_2O_3$ , 14 percent  $B_2O_3$ , and 24 percent  $SiO_2$ . This fabric has excellent strength and flexibility to temperatures over 1000 °C. The fabric is made from fibers 10  $\mu m$  in diameter. The weave is a cross weave type. Each weave bundle contains 390 fibers. The fabric is tightly woven and has the general consistency of heavy burlap. Figure 2 is a photograph of the test fabric.

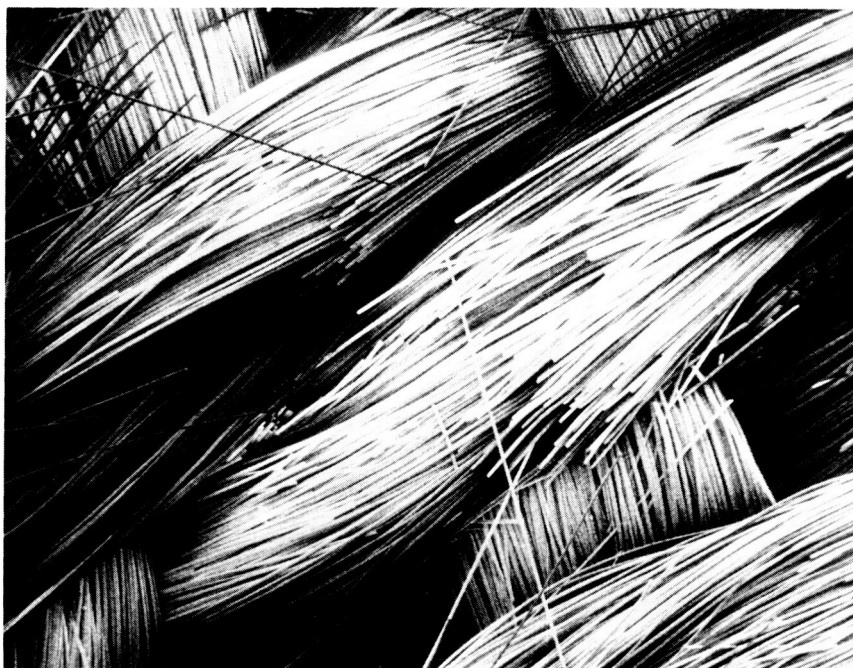
FIGURE 8. - FABRIC FRACTURE AFTER SLIDING AGAINST INCONEL X750. NO LUBRICANT COATINGS APPLIED. (TOP PHOTO 10X, LOWER PHOTO 50X.)

The friction coefficient for the bare AF-40 fabric sliding against the polished Inconel disk was  $0.42 \pm 0.02$  during initial testing at room temperature. Upon heating, the disk began to oxidize and the friction increased. At  $850^\circ\text{C}$  the friction coefficient was very high,  $1.25 \pm 0.06$ . As the specimens were cooled, the friction coefficient decreased gradually to about  $0.60 \pm 0.03$  at room temperature. Subsequent heating and cooling cycles produced friction coefficients of  $0.60 \pm 0.03$  at room temperature, which increased, once again, to  $1.3 \pm 0.1$  at  $850^\circ\text{C}$ . Moderate fiber breakage occurred during these tests (fig. 8).

An SEM analysis of the fabric and the disks after testing indicated that the mode of failure for the fabric is fiber fracture. No fiber abrasion was detected. EDS elemental analysis shows that no lubricants or fibers transferred to the disk surface but there was a transfer of nickel and chromium, or copper depending upon the test, to the fabric surface probably in the form of oxides. These materials may have provided a limited lubricating effect by separating the fabric from the metal counterface (ref. 5).
